IDENTIFICATION GUIDE

This guide serves as a resource in determining if a VORTEX fluid end is failed. All renderings and pictures are for reference only. Key considerations:

Revision 25.2_4/28/2025

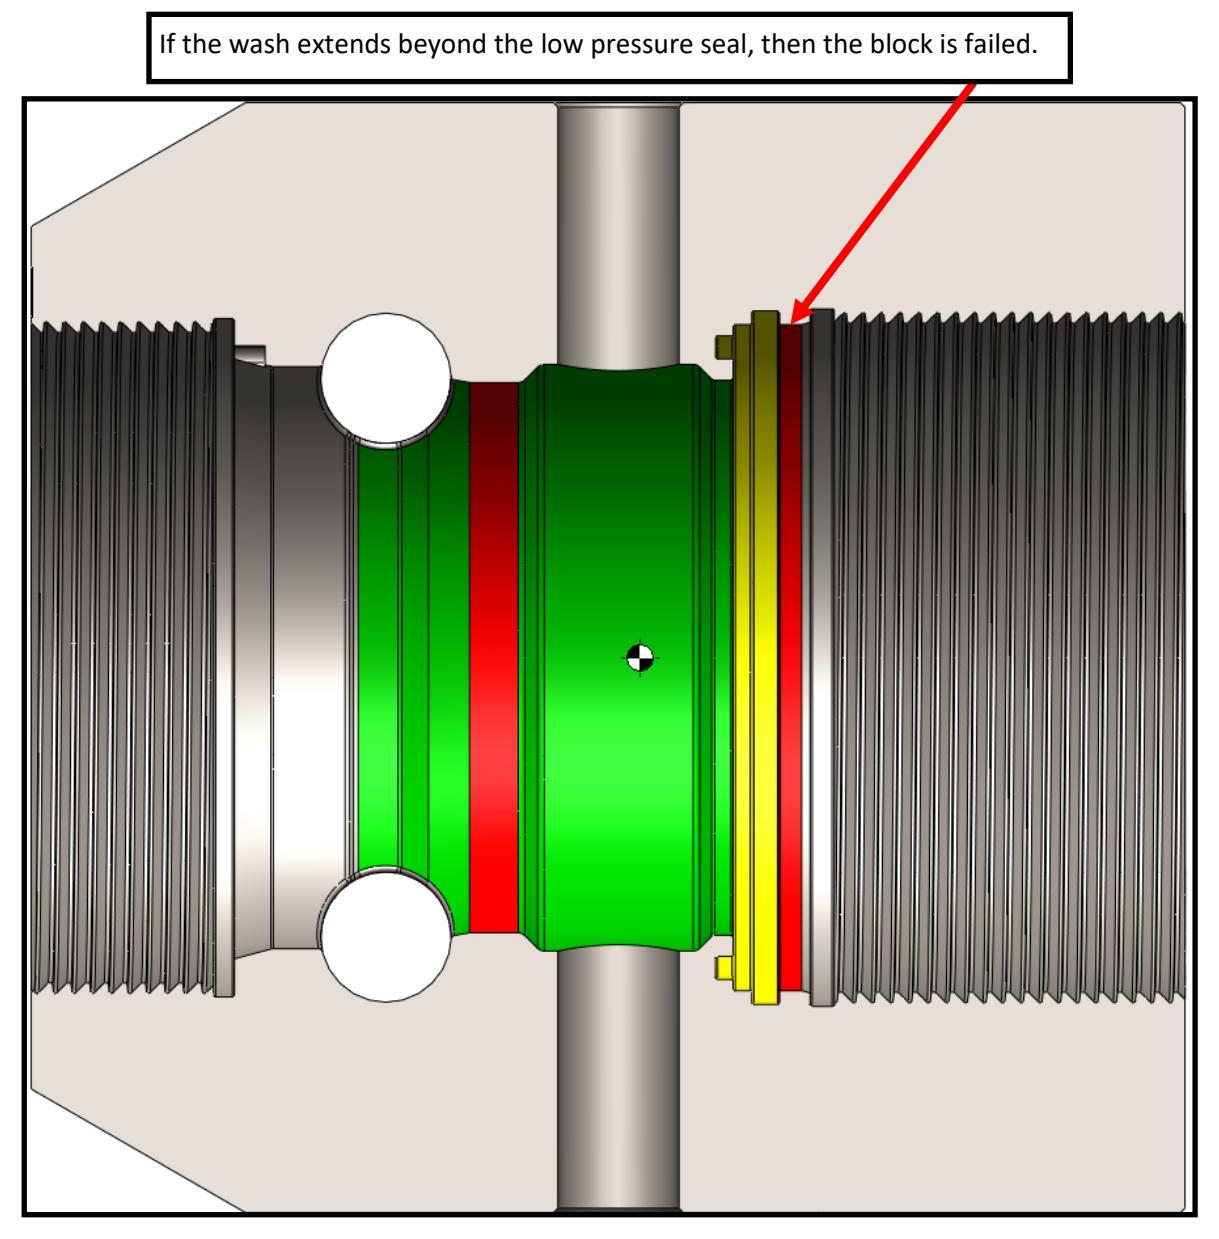
- When in doubt, load a new set of valves and seat to conduct a pressure test. If the new set holds pressure, • keep pumping.
- If wash occurs in the areas shown in green below, load new valves and seat and keep pumping. If the wash • occurs in the are shown in **yellow**, load new valves and seat and keep pumping, but use **caution** as the first low pressure seal has failed. If wash occurs in areas shown in **red**, change the fluid end block.
- The extent of the wash may not be easily determined with the dynamic section threaded in.

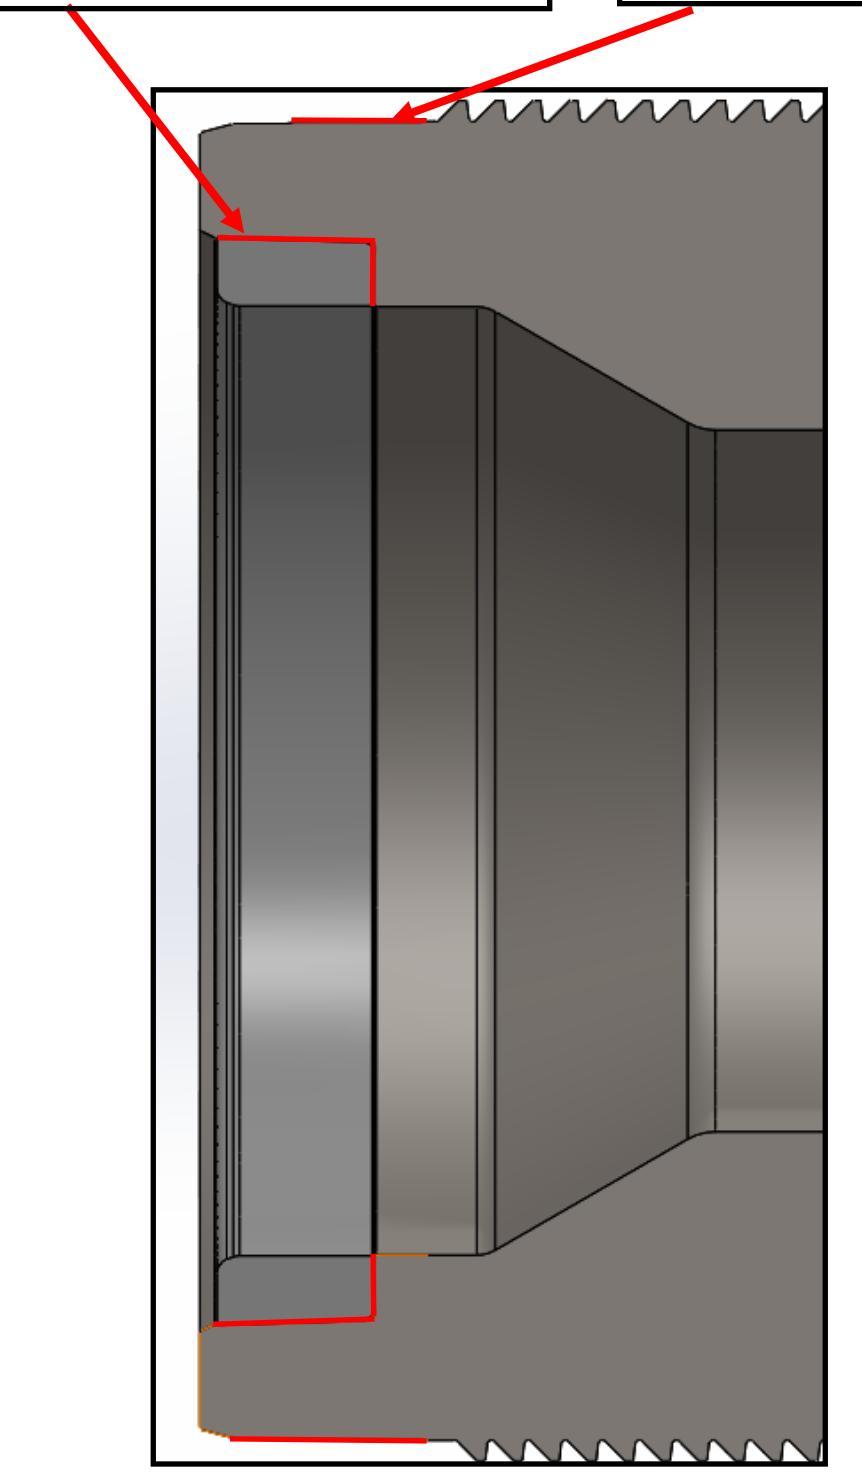
Dynamic Section Failure

If the wash extends from the plunger side of the carbide to the discharge side, the dynamic section is failed.

If the wash extends beyond the low pressure seal on the dynamic section nose, then the dynamic section is failed.

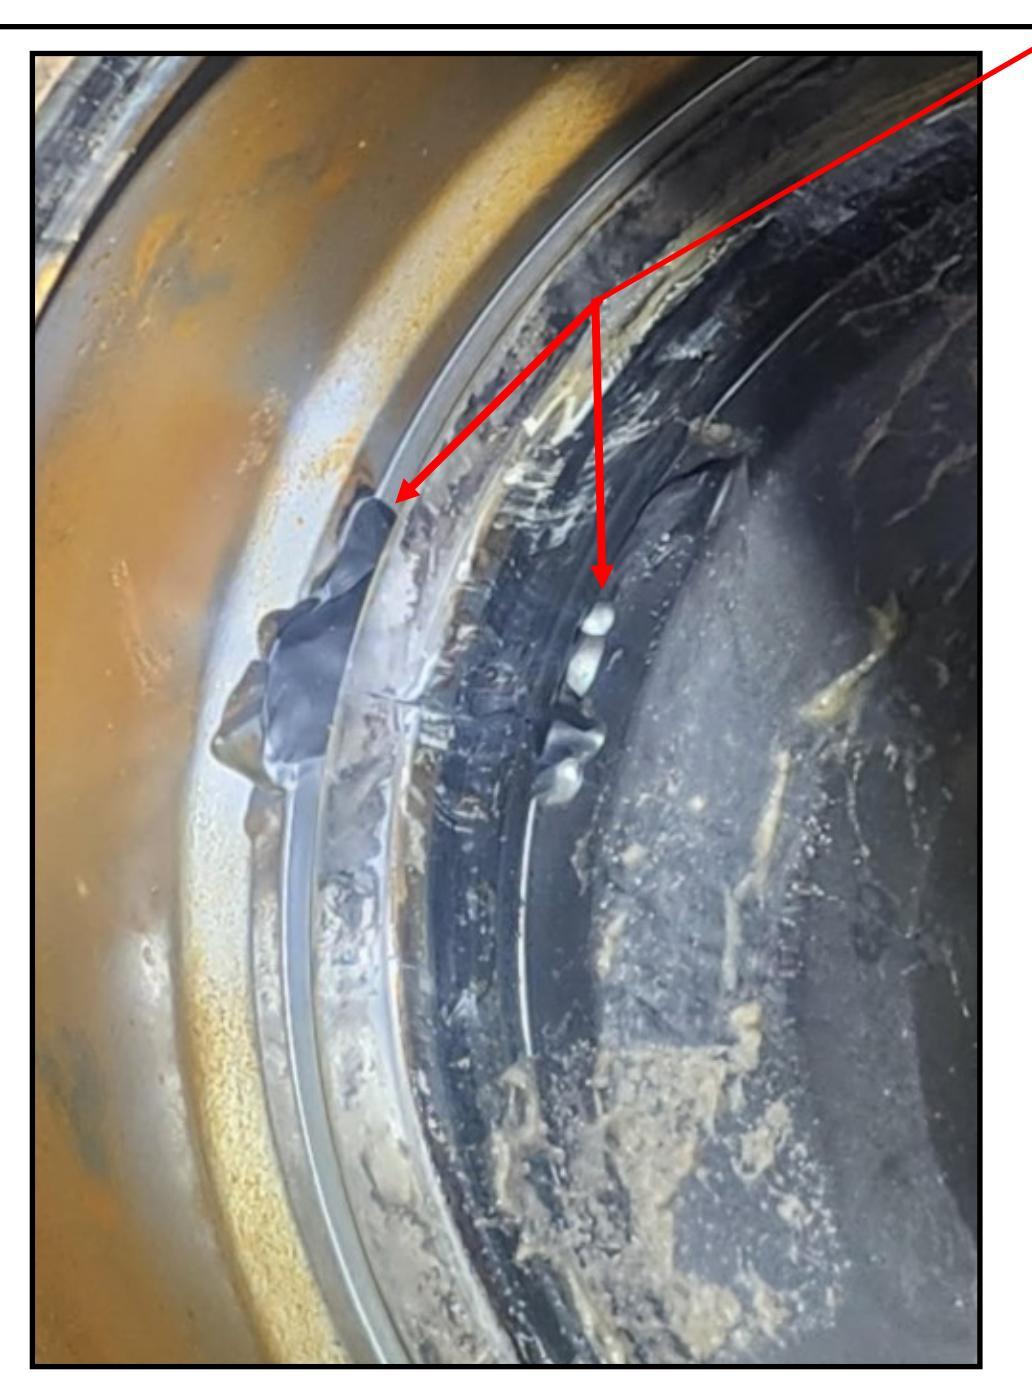
Dynamic Section Failure

Examine the face of the carbide for cracks and chips. If cracked or chipped, the dynamic section is failed.

If wash extends behind the carbide from the seat face to the plunger bore (shown below), the dynamic section is failed.

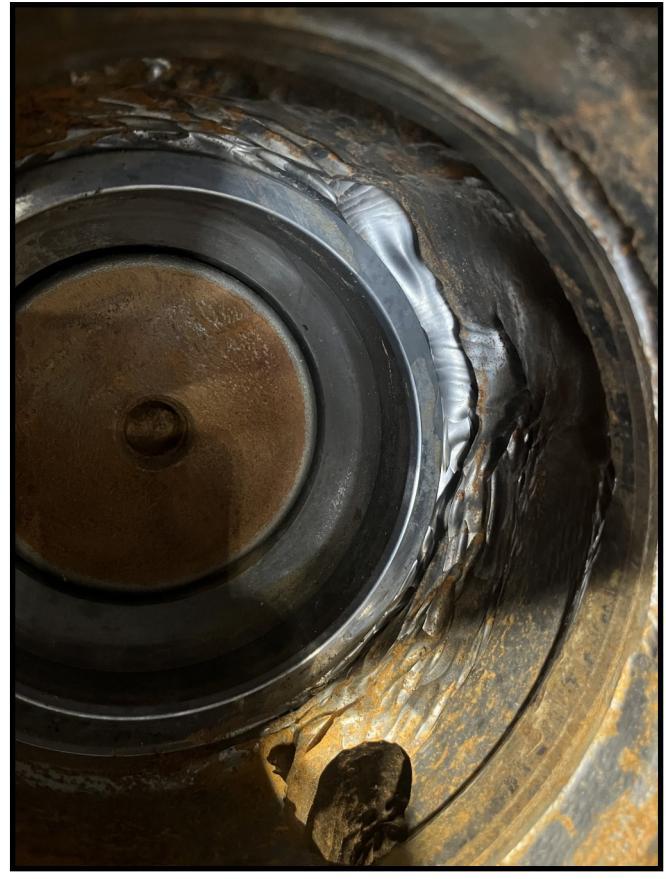
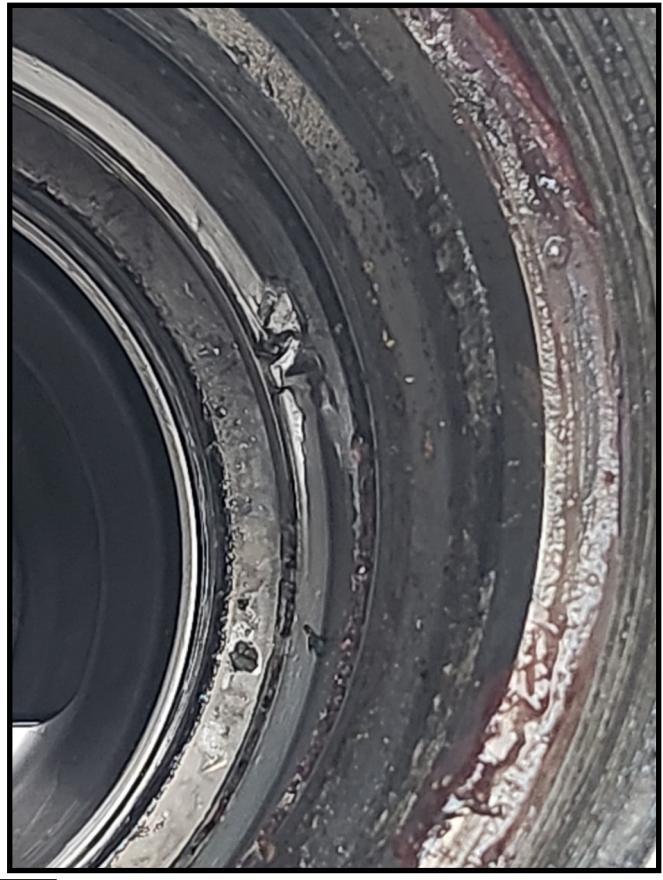
Non-failed Fluid End & Dynamic

The washed areas shown below are visually concerning, however, the wash never leaked behind the carbide. These fluid end should be reloaded with new valves and seat to continue pumping.

Wash occurs in the suction "racetrack" but does not extend into the low pressure seal region or behind the carbide. These are **NOT** failed fluid ends.

When in doubt, load a new set of valves and seat to conduct a pressure test. If the new set holds pressure, keep pumping.

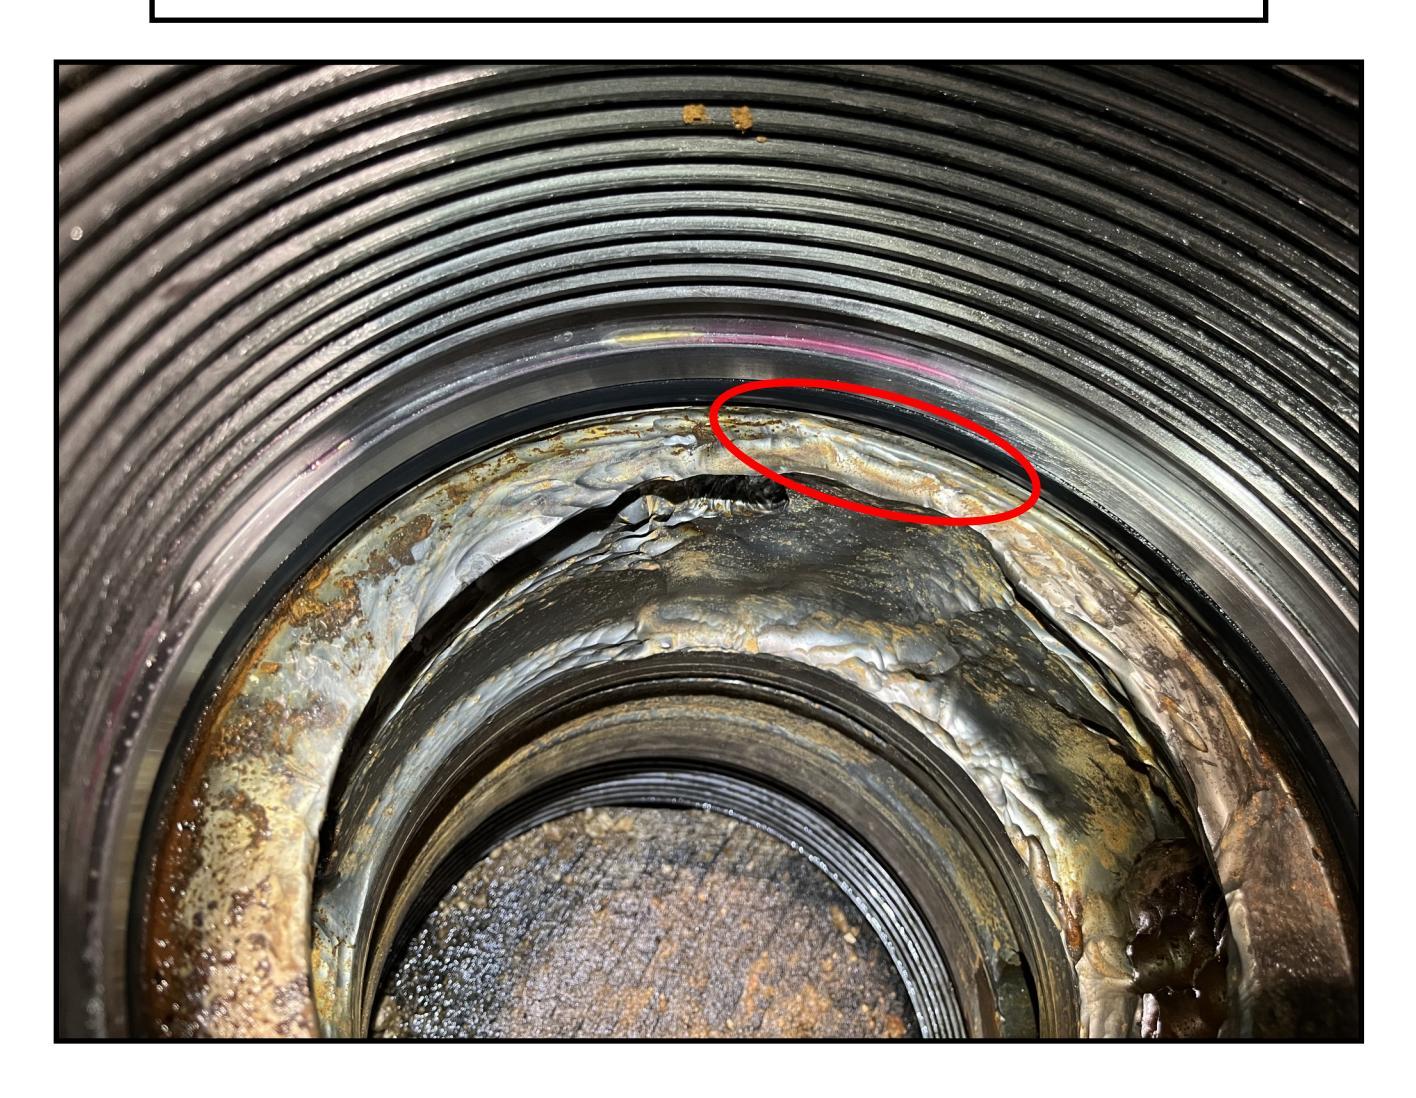
Non-failed Fluid End & Dynamic

The picture below is taken from the packing side of the fluid end, with the dynamic section removed. The wash doesn't extend into the low pressure seal groove, which means the fluid end is still functional.

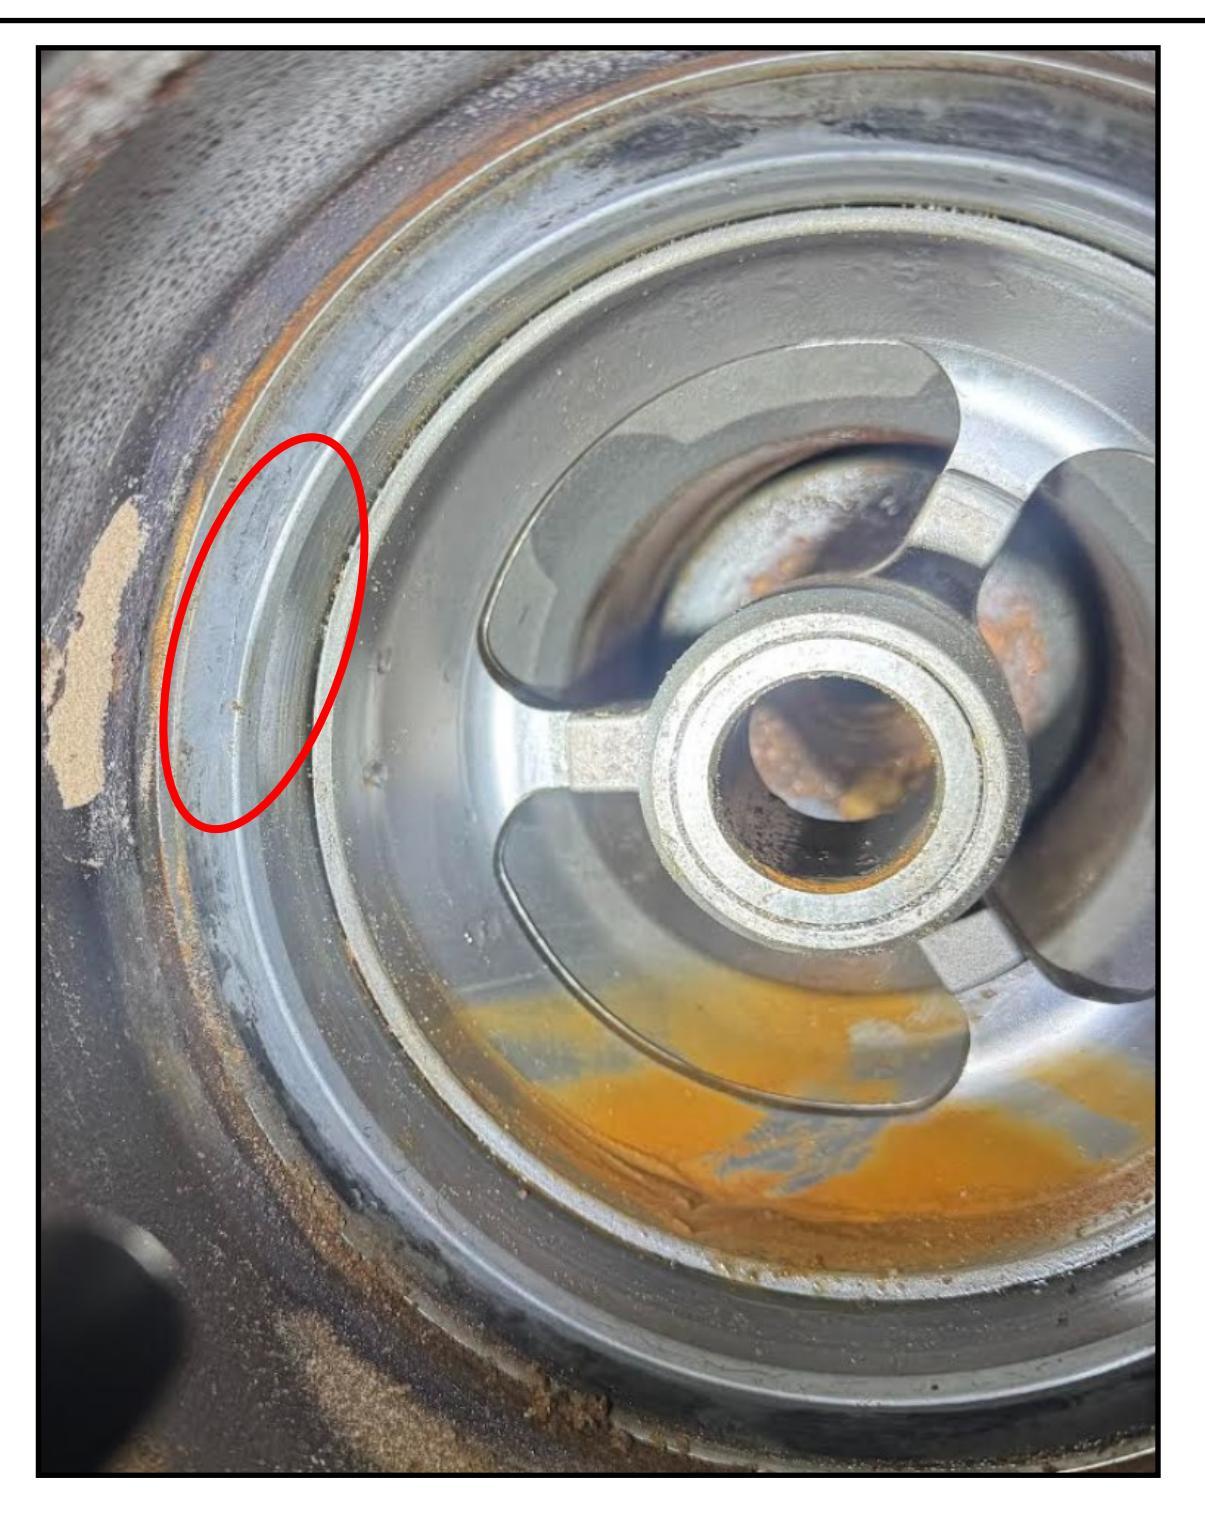
Failed Fluid End & Carbide

The picture below shows a carbide ring with cracks circumferentially along the load face. If this were to continue running, the carbide would eventually crack further and completely fail.

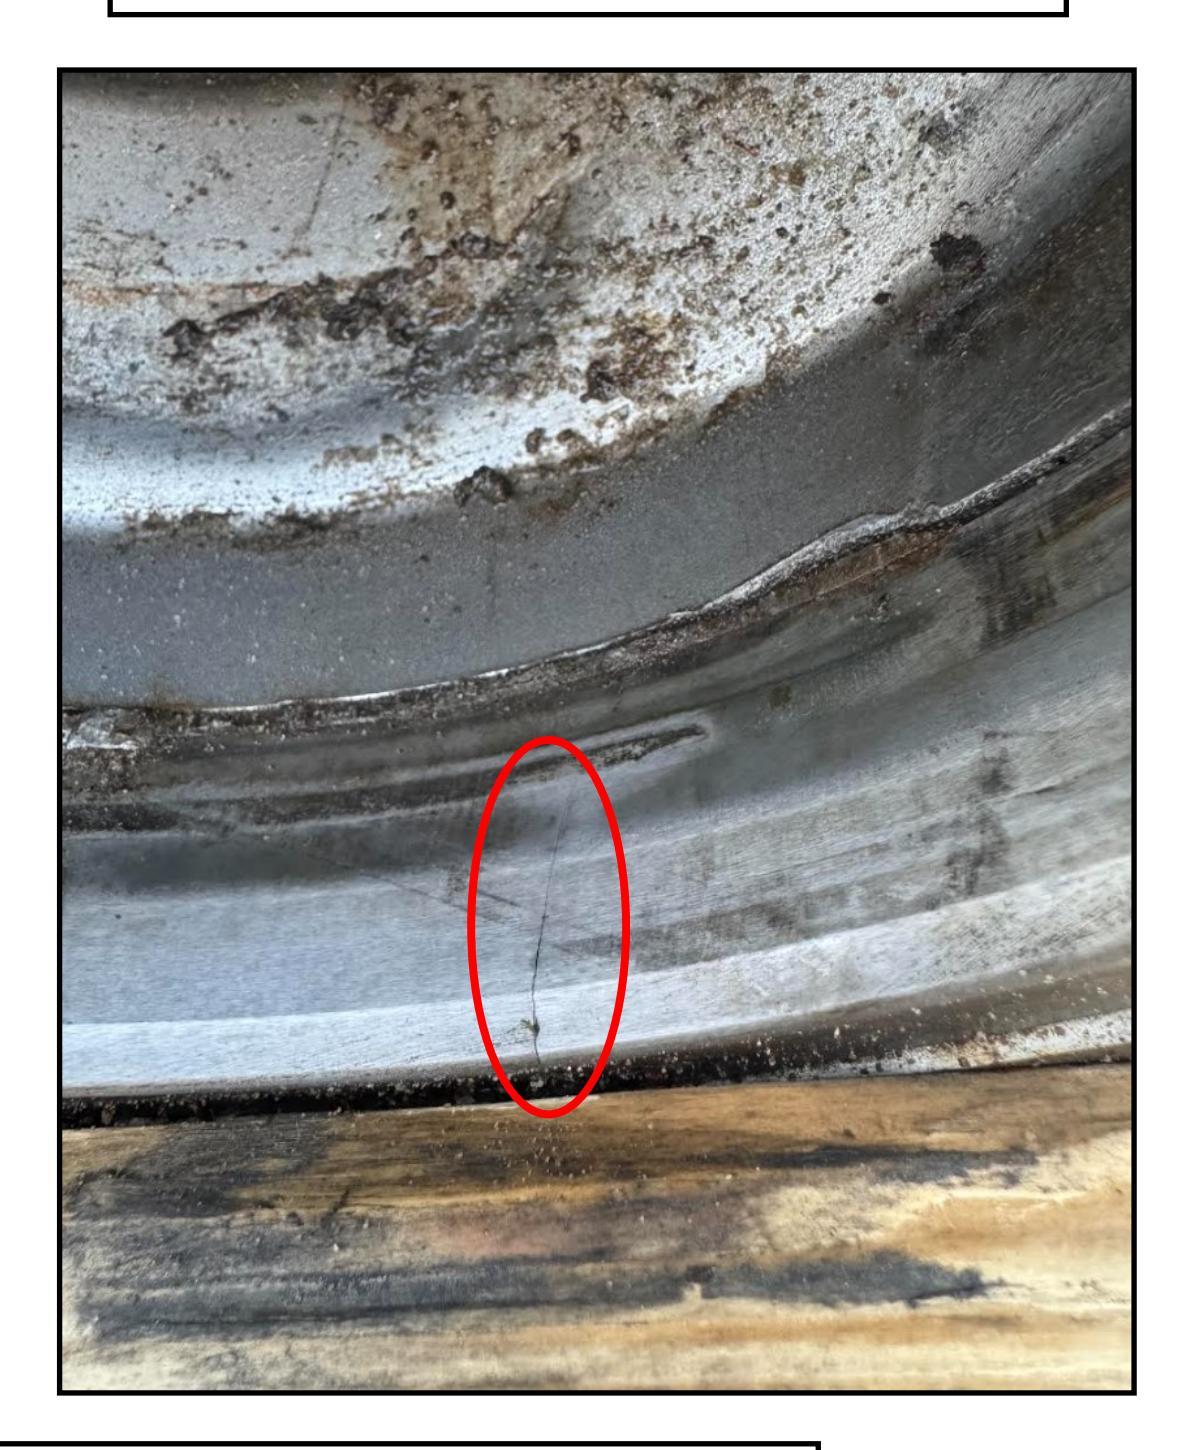
Failed Fluid End & Carbide

The picture below shows a carbide ring cracked axially.
