IDENTIFICATION GUIDE

This guide serves as a resource in determining if a VORTEX fluid end is failed. All renderings and pictures are for reference only. Key considerations:

Revision 25.2_4/28/2025

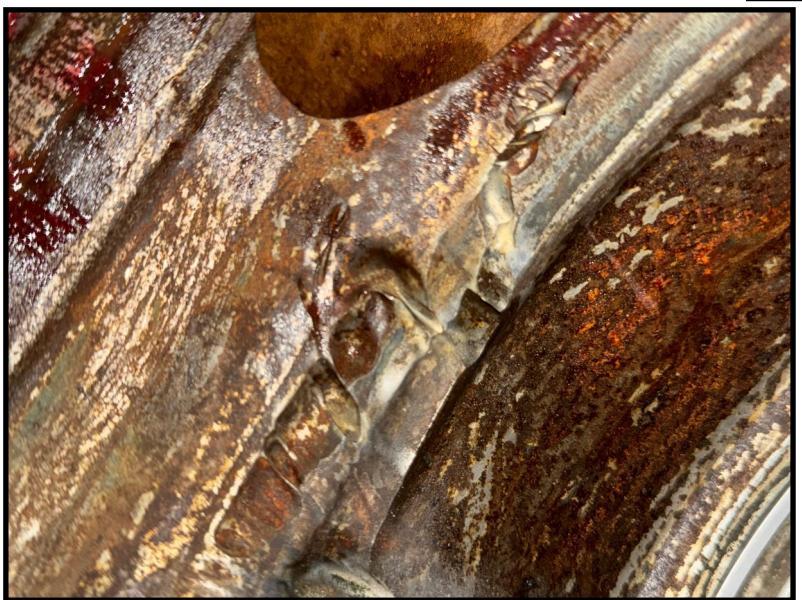
Wash occurs in the suction "racetrack" but does not extend into the low pressure seal region or behind the carbide. These are **NOT** failed fluid ends.

When in doubt, load a new set of valves and seat to conduct a pressure test. If the new set holds pressure, keep pumping.
